Physical Planning, Finance and Building Committee Public Meeting Agenda

To provide the results, recommendations and next steps related to the indoor air quality (IAQ) report for the Education Centre.

Education Centre, 156 Ann Street, Belleville, Ontario
Hastings and Prince Edward District School Board

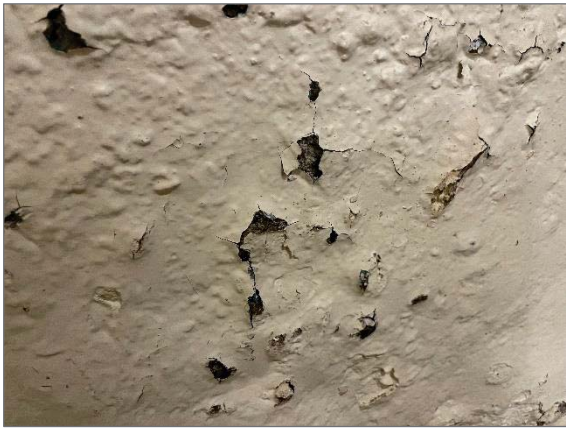
<p>Photo 1 - Mould growth is present behind deteriorated paint on the masonry foundation wall in the mail room (Location 34).</p>

Mould growth was observed behind paint on masonry foundation walls in the mail room (Location 34), on wood shelving in a storage room (Location 22) and on drywall walls in the closet and metal window frames of the quite room (Location 112A).

- Remove and dispose of loose and flaking paint/mortar, clean the masonry foundation walls using abrasive methods such as sanding in the mail room and apply a mould inhibiting encapsulant such as Fosters 40-50

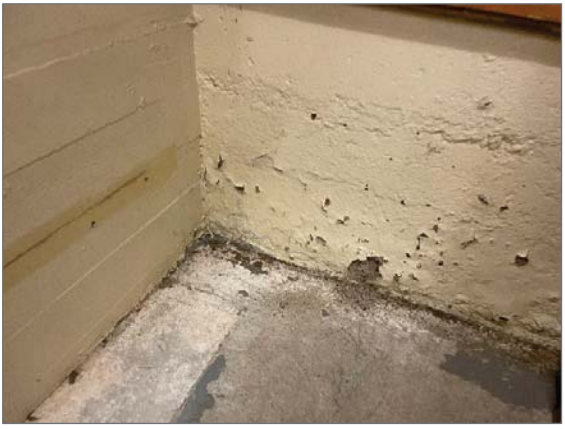
<p>Photo 2 - Deteriorated paint and mortar on masonry foundation wall in the mail room (Location 34).</p>

Efflorescence was observed on masonry foundation walls in the Mail Room (Location 34), a Storage Room (Location 22) and in the closet of the Quite Room (Location 112A).

Flaking paint and deteriorated mortar was observed on the lower one foot of stone foundation walls in various locations throughout the first floor.

The mould growth, water damage and efflorescence identified on the first floor is likely a result of foundation leaks/building envelope issues. The lack of insulation and vapour barrier in perimeter walls in the first floor combined with poor ventilation and periods of elevated relative humidity will result in condensation forming on cool building finishes when the dewpoint is reached.

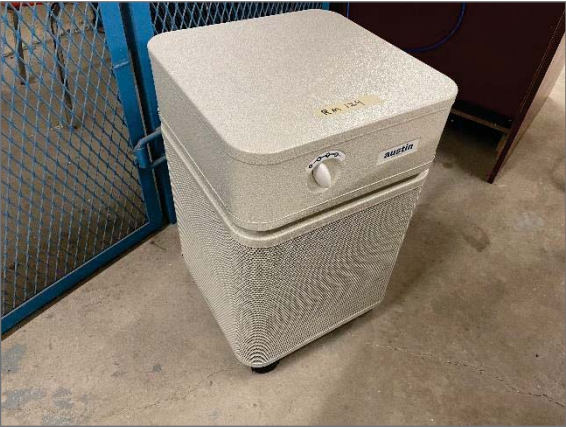
- HEPA filtered air purifiers are present and operational in area workspace occupied by building staff, including the Mail Room (Location 34).
- Housekeeping in the building consists of daily sweeping/mopping and weekly cleaning of horizontal surfaces.
- HVAC in the building consists of boilers with hot water to radiators, a cooling tower system and rooftop air conditioning units which are dedicated to the IT server rooms.
- The air handling unit filters are assessed every month and changed by custodial staff if needed.
- The caretaker reported that there is no fresh air intake incorporated in the building HVAC.
- Multiple floods/leaks have been reported on the First Floor and have been cleaned by building housekeeping staff.

<p>Photo 3 - HEPA-filtered air purifier present and operational in the mail room (Location 34).</p>

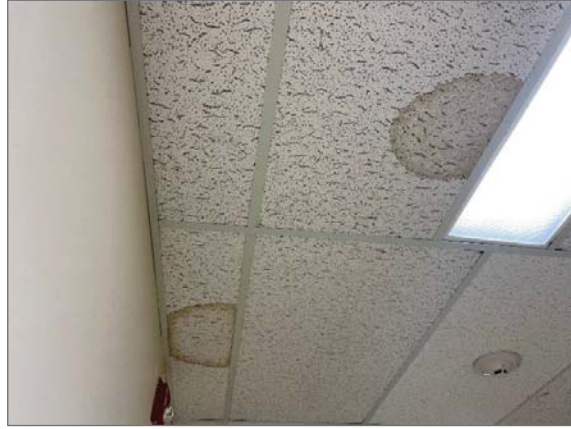
Photo 6 - Water stained ceiling tiles in the west corridor (Location 5).

Accumulations of dust, debris and dirt were observed on horizontal surfaces throughout the first floor. Four water-stained ceiling tiles are present on the first floor. Water damage and mould growth was not observed on the finishes above the lay-in ceiling tiles.

The water-stained ceiling tiles on the first and second floors are suspected to be a result of a former leak originating from the ceiling space. Mould growth was not observed on the ceiling tiles, however; water-stained ceiling tiles can negatively impact the occupant's perception of the indoor air quality. The ceiling tiles should be removed and disposed of, and the new tiles monitored for any ongoing leaks.

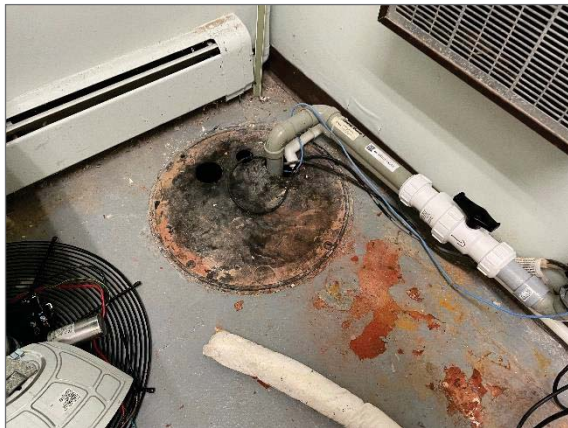
Photo 7 - Sump pump present in the Moira Room (Location 10).

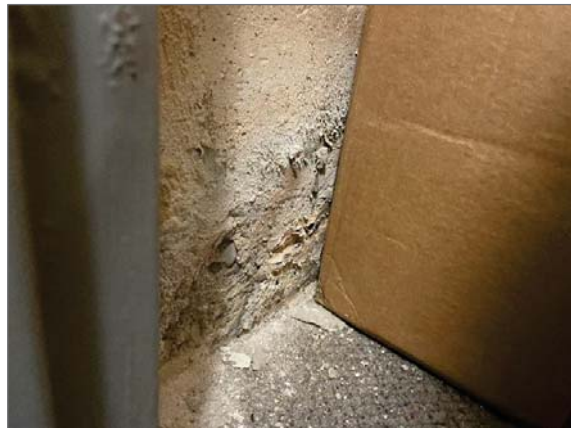
Photo 8 - Efflorescence and deteriorated paint and mortar on masonry foundation wall in the closet of the Quinte Room (Location 9).

- Remove and dispose of loose and flaking paint/mortar, clean the masonry foundation walls using abrasive methods such as sanding in the Quinte Room.
- Remove and dispose of mould impacted and water damaged building materials, including but not limited to drywall, vapour barrier, insulation in the quinte room extending one foot beyond all visible mould growth.
- Clean and disinfect mould impacted metal window frames in the quinte room.

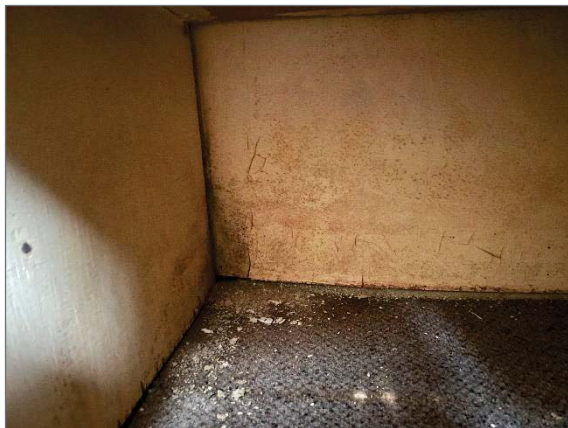
Photo 9 - Mould growth on the drywall wall in the closet of the Quinte Room (Location 9).

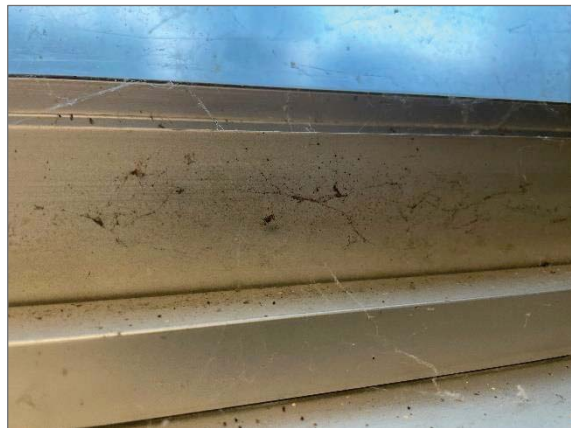
Photo 10 - Mould growth on the metal window frames in the Quinte Room (Location 9).

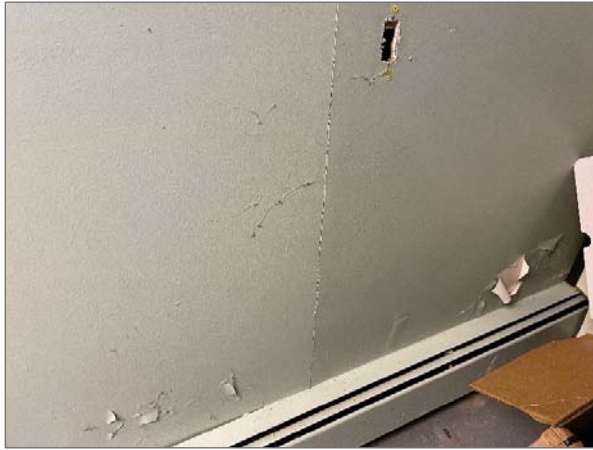
Photo 11 - Water damaged drywall and blistering paint in the quinte room (Location 9).

Water damaged drywall was observed below windows along exterior walls in the quite room (Location 9) and the Moira Room (Location 10).

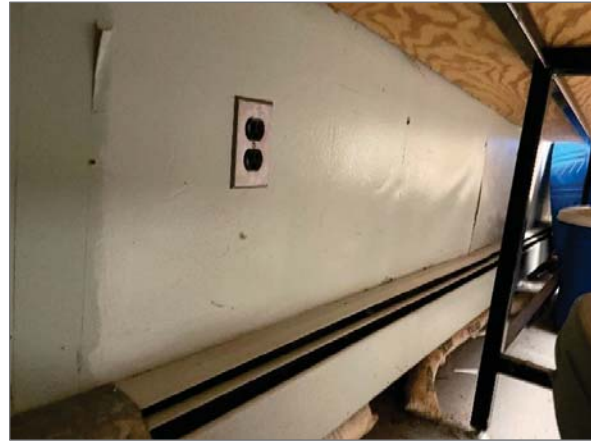
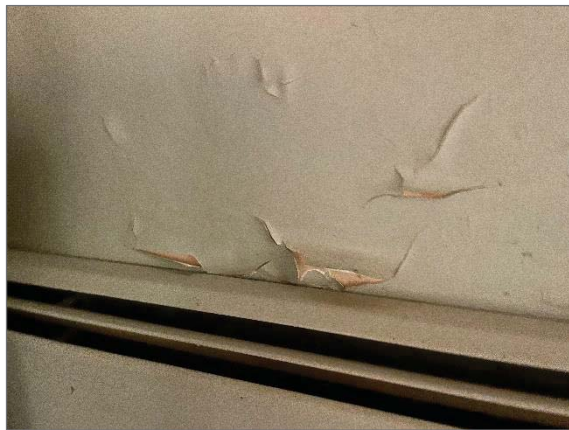
Photo 12 - Water damaged drywall and blistering paint in the moira room (Location 10).

Photo 13 - Water damaged drywall and blistering paint in the moira room (Location 10).

- Remove and dispose of mould impacted building materials, including but not limited to drywall, vapour barrier, insulation etc. from the exterior wall below the windows in the Moira Room extending one foot beyond all visible mould growth.
- Inspect the wall cavity for water damage and mould growth and remediate accordingly.
- If mould growth is present on structural wood framing, clean using abrasive methods such as sanding and apply a mould inhibiting encapsulant such as Fosters 40-50.

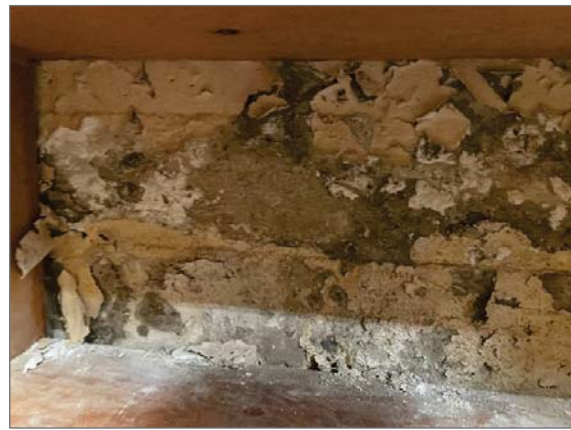
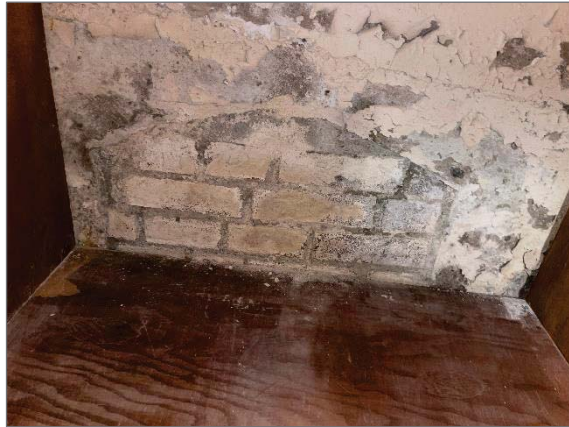
Photo 14 - Efflorescence, deteriorated paint and mortar on masonry foundation wall and mould growth on wood shelving in a storage room (Location 22).

Photo 15 - Efflorescence, deteriorated paint and mortar on masonry foundation wall and mould growth on wood shelving in a storage room (Location 22).

- Remove and dispose of loose and flaking paint/mortar, clean the masonry foundation walls using abrasive methods such as sanding in the storage room.

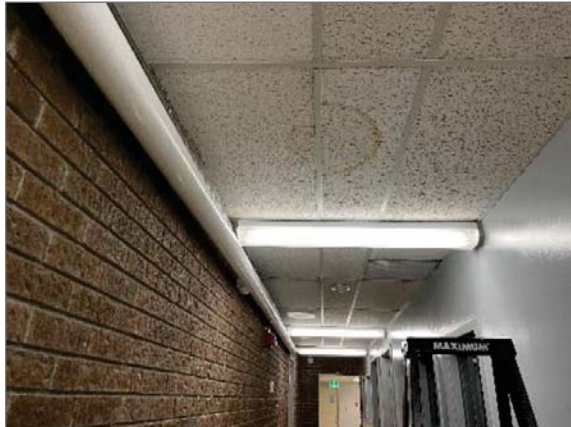
Photo 16 - Water-stained ceiling tiles in the north corridor (Location 8).

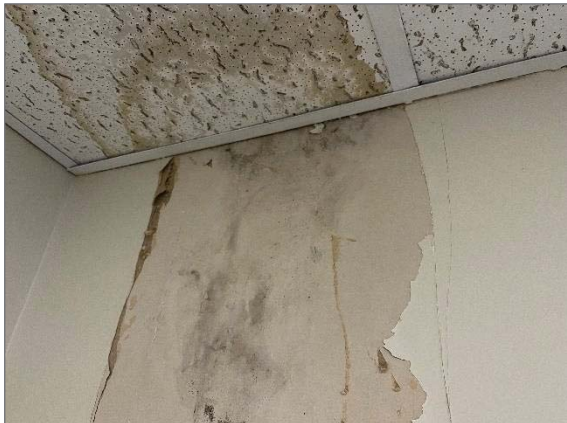
<p>Photo 17 - Mould growth on drywall wall and water-stained ceiling tile in the northwest corner of Location 67.</p>

One water-stained ceiling tile and mould impacted drywall wall is present in the northwest corner of Location 67. A sanitary drain and a drywall patch on the plaster ceiling are present above the water-stained ceiling tile.

The mould impacted drywall and water-stained ceiling tile in the southeast office area (Location 67) is likely a result of a pipe leak; however, a drywall patch was present above the pipe, which may have been a repair following the leak. Water staining and mould growth was not observed on surfaces within the ceiling space.

- Remove and dispose of mould impacted building materials, including but not limited to drywall, vapour barrier, insulation etc. from the northwest wall in Location 67, extending one foot beyond all visible mould growth. If the mould remediation requires more than 1m² of drywall to be removed, Type 2 asbestos procedures must be followed.
- Clean metal windowsill and cabinets with a broad-spectrum disinfectant.
- Inspect the wall cavity for water damage and mould growth and remediate accordingly.

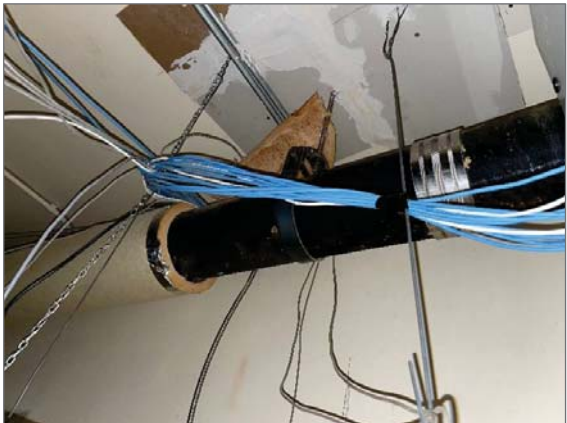
<p>Photo 18 - Sanitary drain and patched plaster ceiling above lay-in ceiling tiles in the northwest corner of Location 67.</p>
